Optical Transmission Scanner - OptiView™

OTS-1000

Non-destructive evaluation (NDE) techniques that can measure both surface and subsurface defects are of critical importance in evaluating the integrity of composites and plastics. The OTS-1000 is a high resolution (lateral), rapid, and non-contact optical transmission scanning system specifically designed for quantitative NDE of such components. Materials with low attenuation in either ultraviolet (FUV to NUV), visible, or infrared (NIR to FIR) spectra are suitable for inspection. Unlike ultrasonic testing (UT) methods, the OTS-1000 has a simpler system design and does not require coupling or sophisticated electronics, thus allowing for rapid scanning and significant cost reduction. The system comes with integrated software, which provides more detailed information about defects, such as the number of delaminations in the cross-section of the sample.

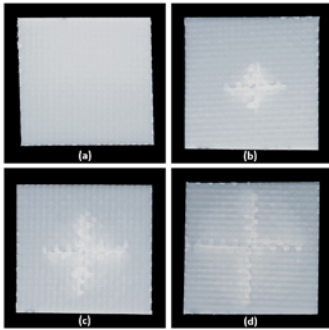
Impacted GFRP Samples

Impact damage example: advanced image processing
